LAWRENCE-WENTWORTH HOUSE

Tech Notes

NUMBER 6

Replacement Wooden Sash and Frames With Insulating Glass and Integral Muntins

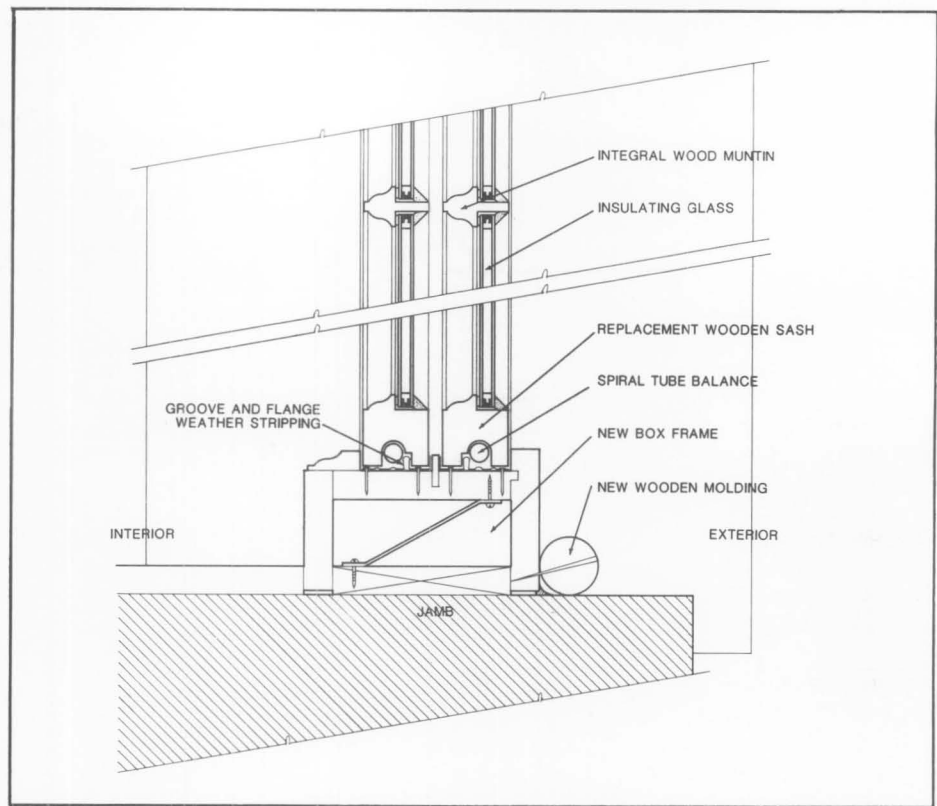
The selected replacement sash were designed to have two individual lights of insulating glass in each sash with an integral (as opposed to a "fake" or applied) muntin. Based on the experience gained by the Lowell Historic Preservation Commission in previous projects, the muntin of the new sash was made only 1" wide, closely matching the appearance of the historic $\frac{3}{4}$ " wide vertical muntins remaining in the upper floor windows (see figure 1). This slight change in muntin width is hardly noticeable. The results might have been different if the old and new sash had existed side by side; if the number of panes had been greater and the panes themselves been smaller; or if the historic muntins had been thinner.

Figure 1. The wooden replacement windows had two individual lights of insulating glass in each sash with an integral (as opposed to "fake") muntin. Drawing: Penelope S. Watson

The historic windows in the Lawrence-Wentworth House were balanced in standard fashion with sash weights and pulleys. Since many were missing on the first floor, less costly spiral tube balances were specified for the new windows (see figure 1). The spiral tube balances were attached at their top to the face of the jamb near the top of the window. The longer balance tube for the lower sash, therefore, is visible above the closed lower sash inside the building, just as the sash cord is exposed on a weight balanced sash. The tube balances, however, are not seen from the exterior and their use permitted a more energy efficient window frame. The empty boxes, which would have held the sash weights, were filled with insulation; air infiltration was further reduced since there were no pulley mortises in the frame.

The spiral balances also allowed the use of a less expensive L-shaped, shop-fabricated frame, and the look of the historic box frame was accomplished with masonry-anchored nailers, steel framing clips, and flat interior casing stock (see figure 1).

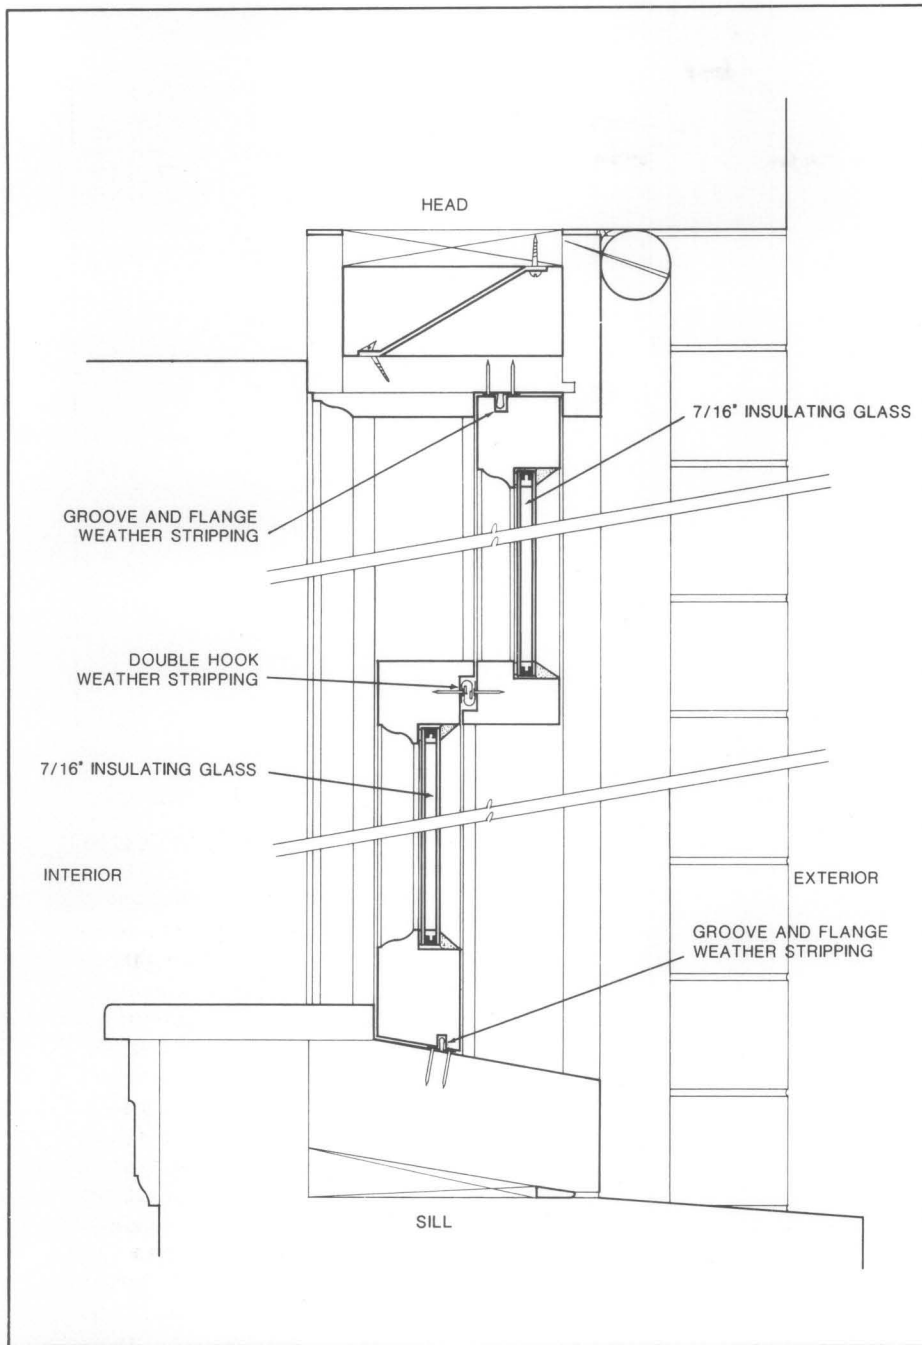
from rolled zinc sheets, were installed in preference to a less permanent vinyl, foamed plastic, or spring-metal weather stripping. At the heads, jambs and sills, the weather stripping consists of a continuous flange over which fit the grooved rails and stiles. At the meeting rail, the weather stripping consists of two interlocking hooks (see figure 2). The weather stripping protrudes only a short distance above and below the meeting rails along the jambs and is almost totally concealed when the windows are shut. It is extremely durable and is virtually unaffected by corrosion or chemical decomposition.

Figure 2. Several types of zinc weather stripping were used. Drawing: Penelope S. Watson

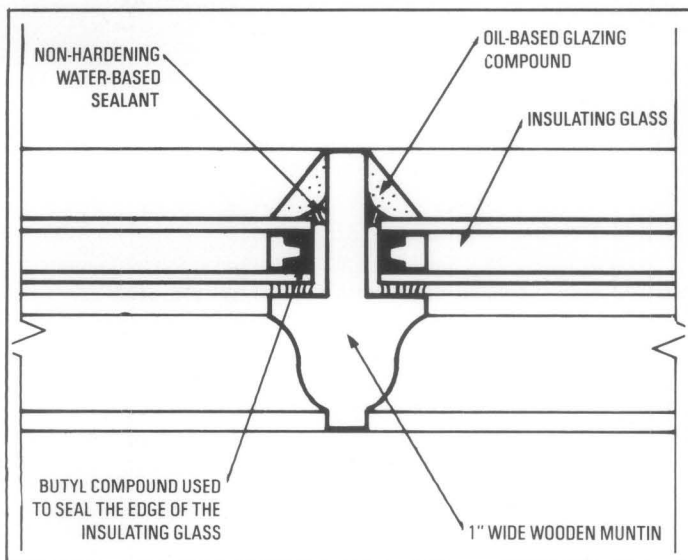
The sealed insulating glass units, installed in the fabricator's shop, were first caulked with a thin bead of non-hardening water-based (containing no oil) sealant. The sealant was applied at the corner of the glass unit so as not to touch the butyl compound used to seal the edge of the insulating glass (see figure 3). The water-based sealant serves as an important barrier between the separate butyl-seal on the insulating glass and the standard oil-based glazing compound as used in the actual glazing. The oil-based glazing compound was chosen in preference to the standard wood molding strips to provide a cheaper, more flexible and more weather-resistant

Figure 3. Glazing detail shows how the non-hardening water-based glazing sealant was used to separate the butyl compound (used to seal the insulating glass) from the oil-based glazing compound. Drawing: Penelope S. Watson

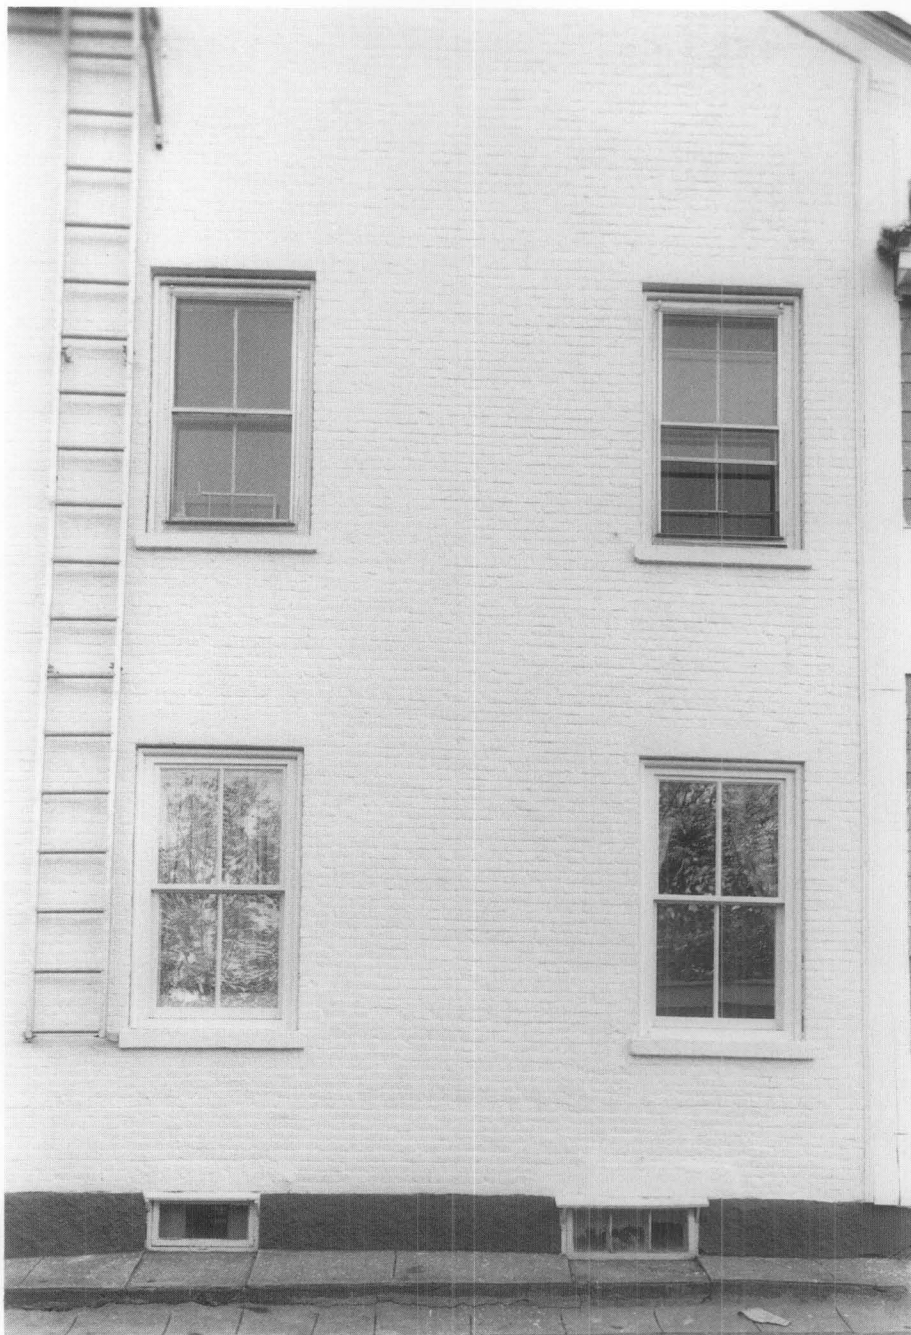
The new wooden frame was thus identical in appearance to the historic frame on the building. The width of the historic frame was reproduced along with the wooden brick molding used to trim the exterior of the masonry openings (see figure 4).

Figure 4. The new wooden windows on the first floor with insulating glass installed closely matched the historic windows which were preserved on the upper floor. Photo: Charles Parrott
