# “And, Where Possible, Materials” — Considering Alternative Materials

By Sharon Ferraro

By Bob Yapp

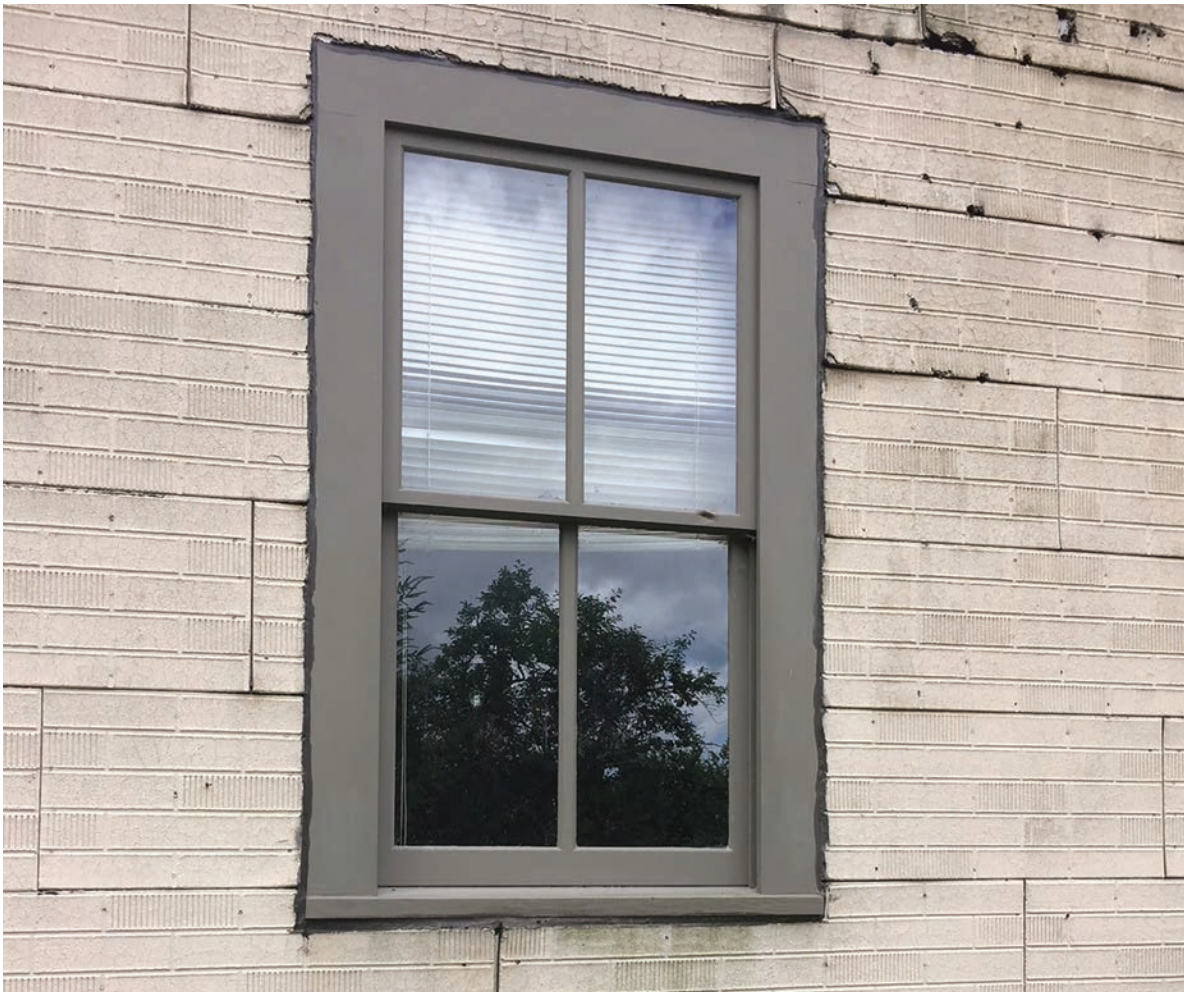
**Asphalt/fiberboard siding, trade named Insulbrick, applied in the 1940s to an 1880s miner's cottage.**

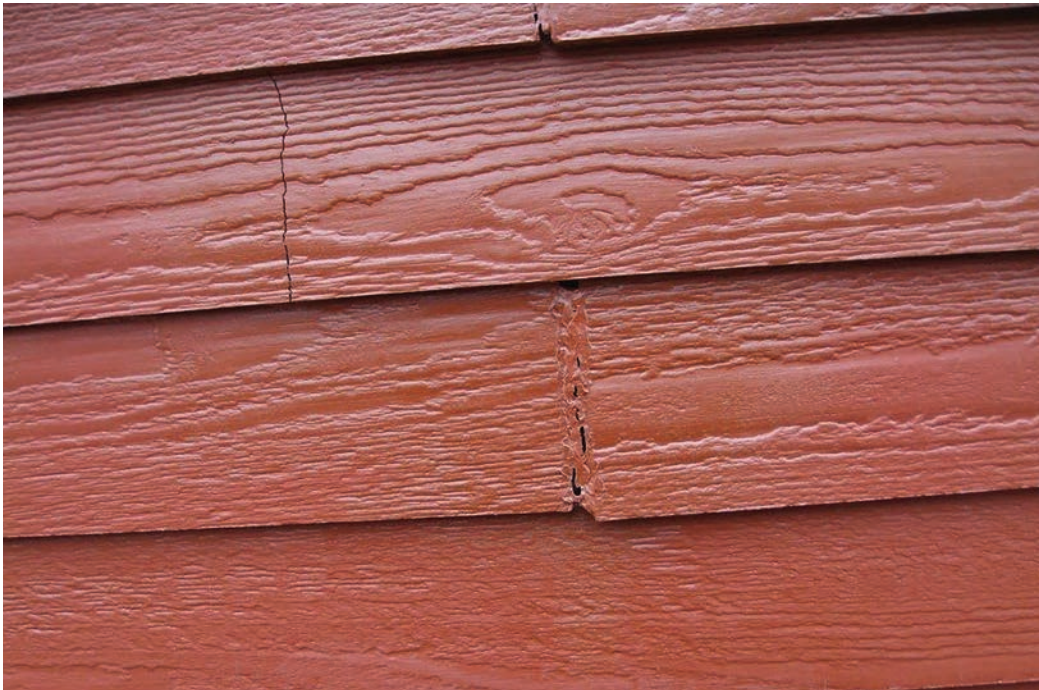
**Fiber cement siding (one common trade name is HardiePlank) showing a false wood grain.**

There will be cases where the only reasonable alternative is a matching replacement material. Design, dimensions, color and texture should be the closest match possible. While cementitious replacement siding, such as those made by Hardie or Boral have textured material with a deep faux grain, they also make smooth siding that looks very much like new wooden weatherboards. The applicant should supply a sample of the material. Often samples can be obtained from suppliers with a phone call, through the website or at a retail store. If possible, a sample of the authentic historic material may be useful for comparison. Photos are second best for evaluation and should always show the material applied to a building not just a photo of the product.

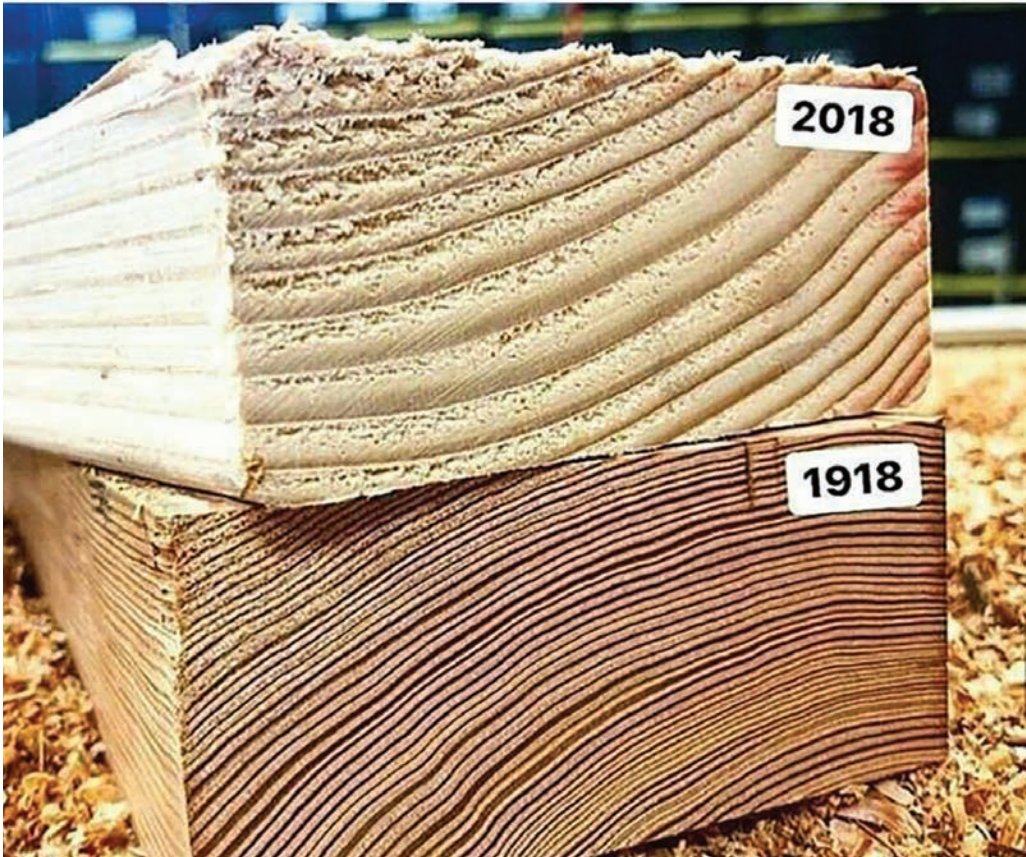
**A comparison of new and old growth lumber.**

Awesome comparison of an old growth 2x4 vs a new growth 2x4. Notice the old growth has 60 rings and the new growth has 16. The old wood is more dense, stronger, burns slower and is more insect resistant. The new wood was grown for the sole purpose of being used for timber and the old growth was taken from natural forests which we have very few natural forests left.

Is a matching material available and of a similar quality? Wood for wood, stucco for stucco, cedar shingles for cedar shingles? This is a big question. Old growth lumber, common in many old houses, has a fine grain and is 30% stronger than the same species grown today. In the virgin forests, trees grew close to each other and grew less each year producing slender growth rings and a tighter

grain. Modern lumber of the same species is often plantation grown, with optimal spacing for rapid growth and making a wide grain and a weaker, less rot resistant wood. A piece of modern lumber of the same species and with the same dimensions can weigh as much as 25-30% less than a piece of old growth wood. And wood or other material needs to be shaped to match the historic material like replacing a beadboard porch ceiling or turned balusters.

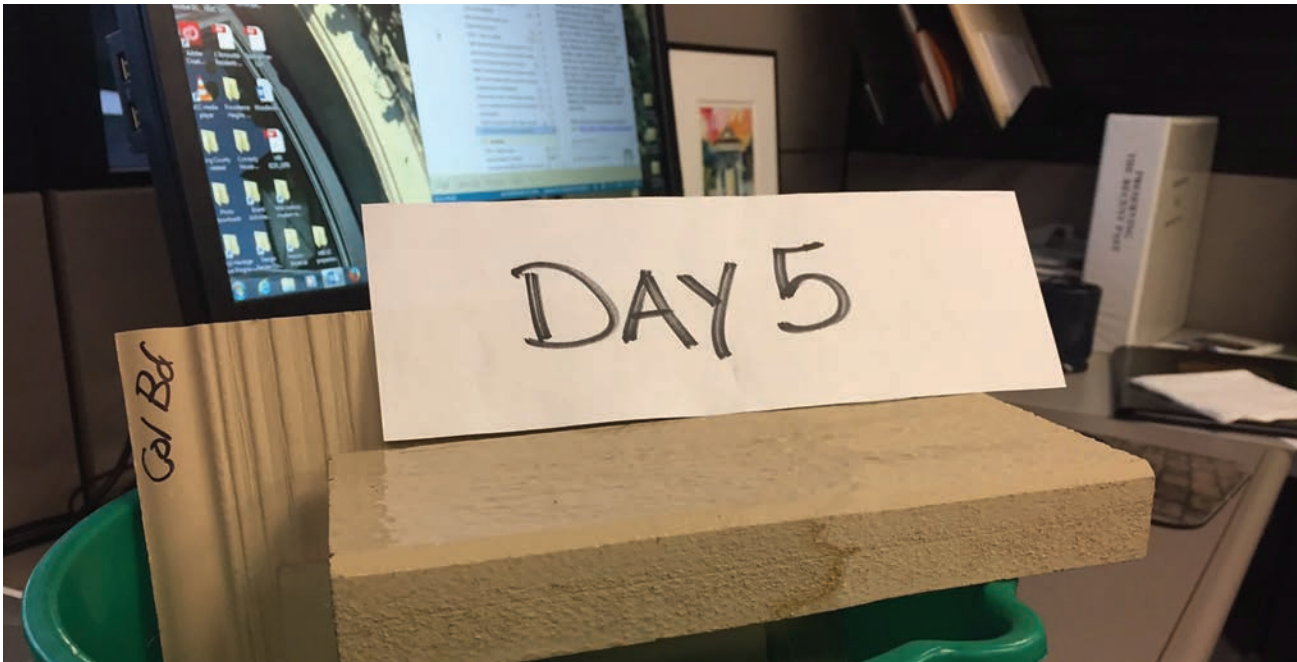
**Testing alternative building material's resistance to moisture in the NAPC field office.**

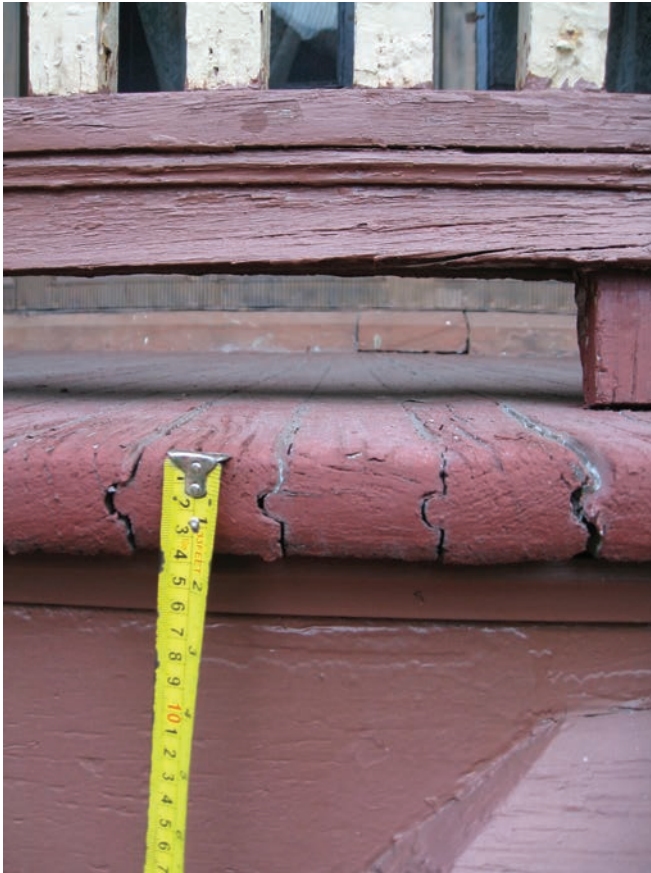
**Historic narrow tongue & groove porch flooring.**

double the width of the authentic, it cannot be painted, and most all authentic, wooden porch floors were painted, gray, green or red. Painted wooden porch floors never show the grain and all the alternative flooring has a textured wood grain that also hold mold and mildew.

Authentic 3¼" x ¾", new, old growth, vertical grain, douglas fir porch flooring is available from multiple sources. Salvaged, douglas fir flooring is also available from multiple salvage operations across the country for less money than the new, old growth, douglas fir. This example cuts across every single exterior feature with similar results. That includes porch and staircase balustrades, exterior doors, vinyl or cement board siding, cladding, masonry repair, windows, and most roofs. With a few simple Google searches, authentic materials can be found. Also, in our studies of various communities large and small, there are contractors who can do the work.

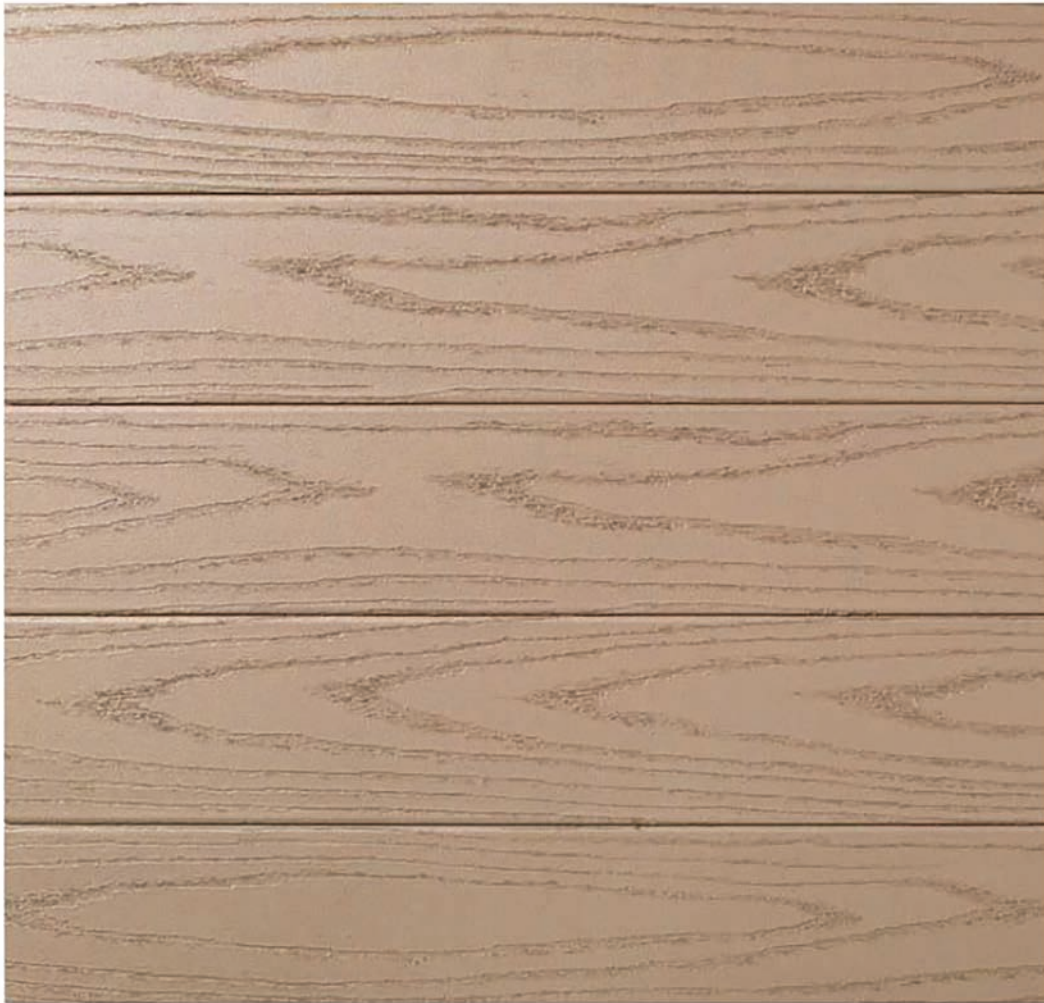
New polymer flooring showing enhanced faux wood grain.

Since the “new feature shall match the old in design, color, texture, and other visual qualities and, where possible, materials.” The argument must be made that the alternative composite or vinyl-based decking can never achieve any of these requirements. It is almost
