## LYNDHURST GATEHOUSE

# Tech Notes

NUMBER 3

### Exterior Storm Windows: Casement Design Wooden Storm Sash

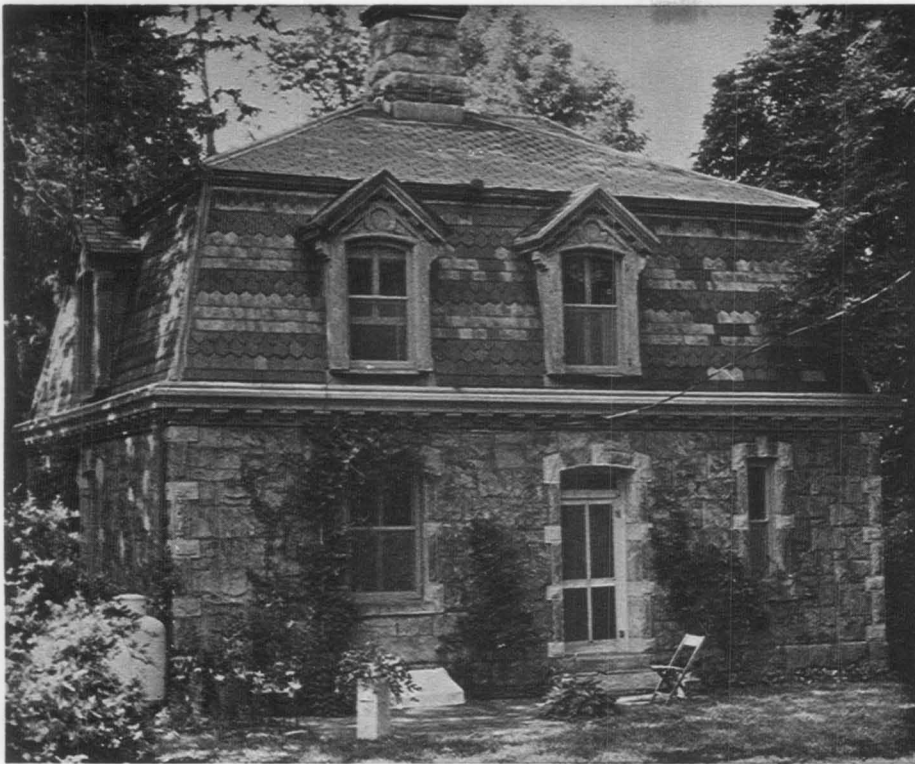
**Figure 1.** The single casement, wooden storm window had two removable panels for screen and glass inserts. This custom design fulfilled a variety of requirements established for the project with minimum physical damage and visual changes to the historic windows. Drawing: Martha L. Werenfels

dows and attached to the existing frame (see figure 1). The arched-headed wooden storm window with one-over-one glass panes matched the size of the original double-hung sash. Molding details similar to the original were incorporated in the new storm sash. Each of the two panes in the storm sash was set in thin aluminum frames and secured in the wood storm window with standard clips. This installation technique enables the storm panels to be easily removed by a person on the inside of the house and replaced during the summer with screens (see figure 2).
