**TRUMAN HOME  
HARRY S TRUMAN  
NATIONAL HISTORIC SITE  
Independence, Missouri**

**PRESERVATION  
Tech Notes**

**EXTERIOR  
WOODWORK**

**Paint Removal from  
Wood Siding**

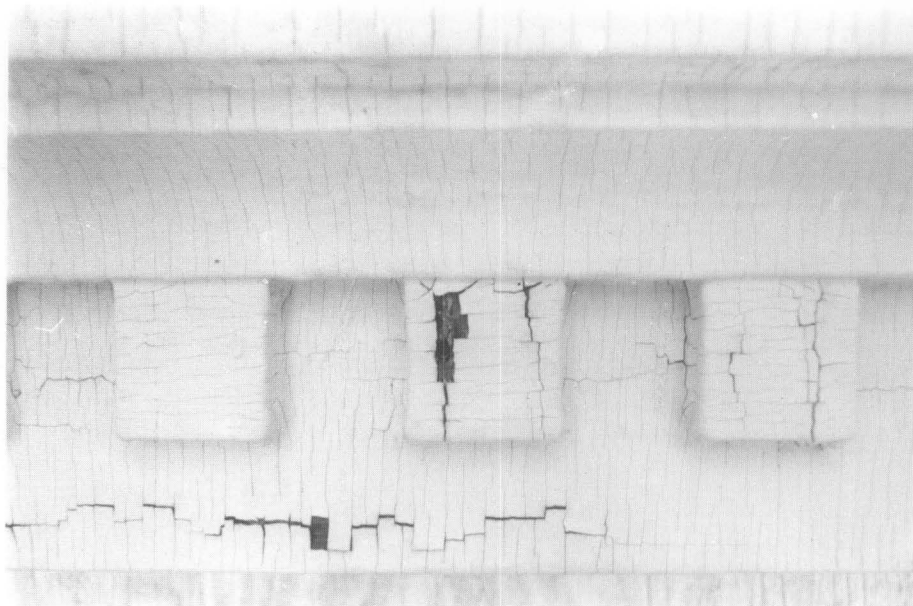
Examination of the exterior paint finishes in areas directly exposed to the elements revealed severe paint film failure, including cross-grain cracking, alligatoring, and peeling (see figure 1). Even in places shielded by porches and cornices, moderate paint film failure had occurred. A number of exposed areas, including soffits, fasciae, and siding, experienced near total paint failure due to recurrent moisture penetration from deteriorated roofs and built-in gutters. Windows were also in very poor condition; many exhibited loose glazing, broken glass and rotted sash. More than 20 coats of paint concealed deteriorated woodwork and cladding from direct examination. On much of the projecting mill work, the final layers of paint had been applied so heavily that stalactites in excess of one-quarter inch were apparent due to paint dripping.

**Figure 1.** Detail of a cornice dentil shows the severe cracking and failure of paint finish. Photo: Alan O'Bright

bathroom causing the paint to peel off in hand-size sheets. It was clear the exterior finishes had lost most, if not all, of their elastic integrity. In order to achieve a sound surface for painting, the decision was made to remove a majority of the exterior paint finishes to bare wood in preparation for a three-coat paint application.

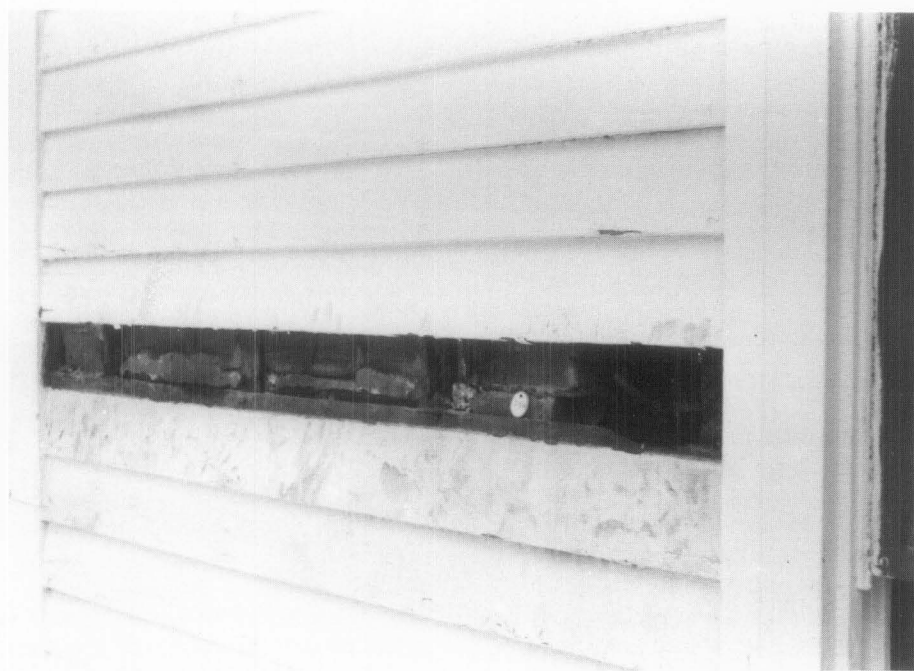
As part of the planning required before the selection of the paint removal method, a physical investigation was conducted of the exterior structure to determine the method of construction and condition (see figure 2). This is particularly critical whenever paint removal is planned. Decisions as to which paint removal methods will be used—especially methods involving heat—are in part guided by the potential flammability of the wall material and debris in the wall cavity and cornices. Sections of lapped siding were carefully removed and the underlying board sheathing cut with a hole saw to reveal the wall cavities. Fortunately, the bulk of the balloon-framed structure was found to be in good condition and the project team believed that potential fire risks could be minimized. With the exception of the 1884 addition, all wall cavities had been filled from foundation sill to soffit with soft brick and mortar.

**Figure 2.** In assessing the safety of using thermal heat to remove paint from the siding, an investigation was performed to determine wall construction and condition. In this portion of the structure, there was no sheathing backing the siding but brick nogging extended from the foundation to the soffit. Photo: Alan O'Bright

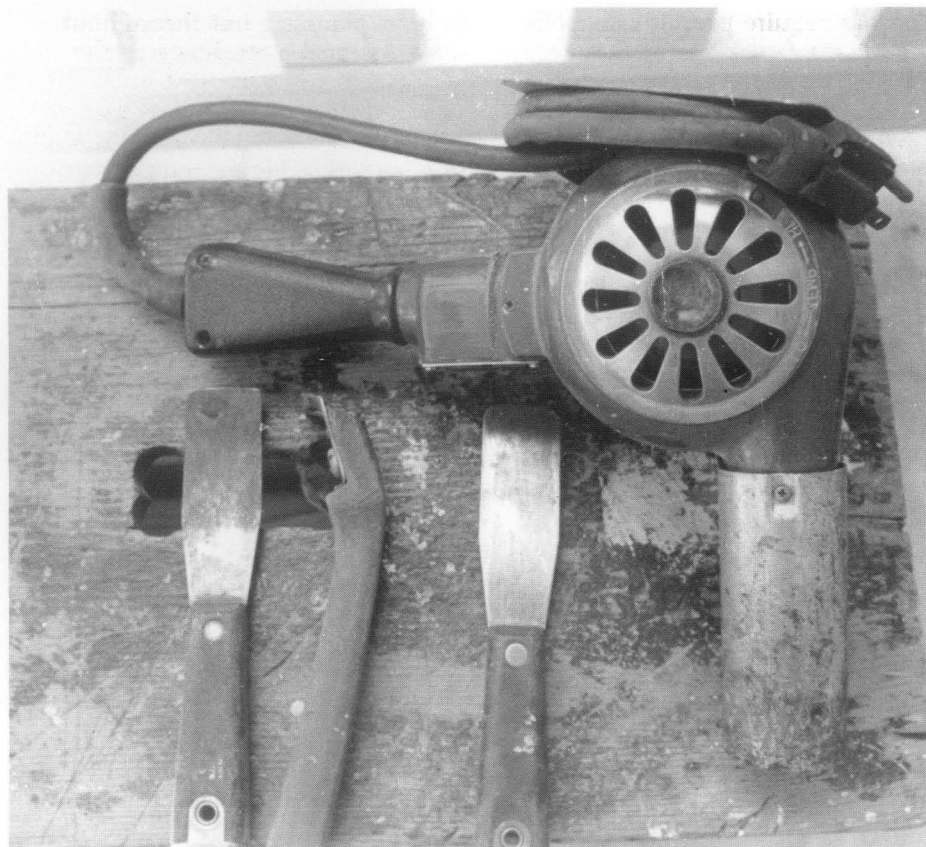
A heavy-duty heat gun was approved for the contractor's use (see figure 3). The metal encased unit featured variable heat control (500-750° F) through adjustable side vents, and a cool down switch, which extends the life of the replaceable heating elements. Since these elements can have a working life as short as 60 to 80 hours, extra elements were purchased and were available at the site for immediate replacement of those in the five heat guns used in the project.

**Figure 3.** Heat guns, putty knives with corners rounded, and paint scrapers were used in paint removal. Photo: Michael Lee

During paint removal the scraped paint tended to adhere to the putty knife, slowing the paint removal process. The workers tried several putty knives and scrapers, but none was successful in shedding the paint residue from the blade. Therefore, the knives had to be periodically cleaned of gummed paint with another putty knife. For siding, a 2 to 2½ inch-wide rigid putty knife worked best. Narrower blades were used for millwork and tight spots. To reduce chances of the workers gouging the wood with the putty knives, the edges of the blades were rounded using a grinder.

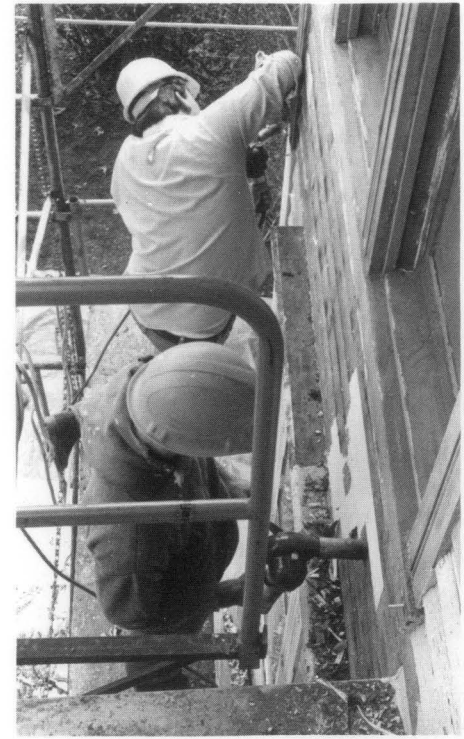
worker alternately heated and scraped the surface. Time was lost in this method because the heat gun had to be set down periodically in order for the worker to clean his putty knife. The second technique, developed by the contractor's site supervisor, was to fasten two heat guns together side by side using metal bars bolted to each gun base (see figure 4). In this way one worker heated the surface while another scraped in a continuous process. This method worked very well for expansive areas of siding and attained an average rate of 8 to 10 square feet per crew hour. On siding in tight areas where one worker operated a single heat gun, paint was removed at a rate of approximately 4 square feet per crew hour (see figure 5).

**Figure 5.** Using scaffolding, workers remove the paint with heat guns. Cracked or deteriorated siding was repaired or replaced. Photo: Alan O'Bright

The siding was inspected for rot and cracks, and suspect sections were marked for repair or replacement. The marked sections were passed over in the paint removal process.

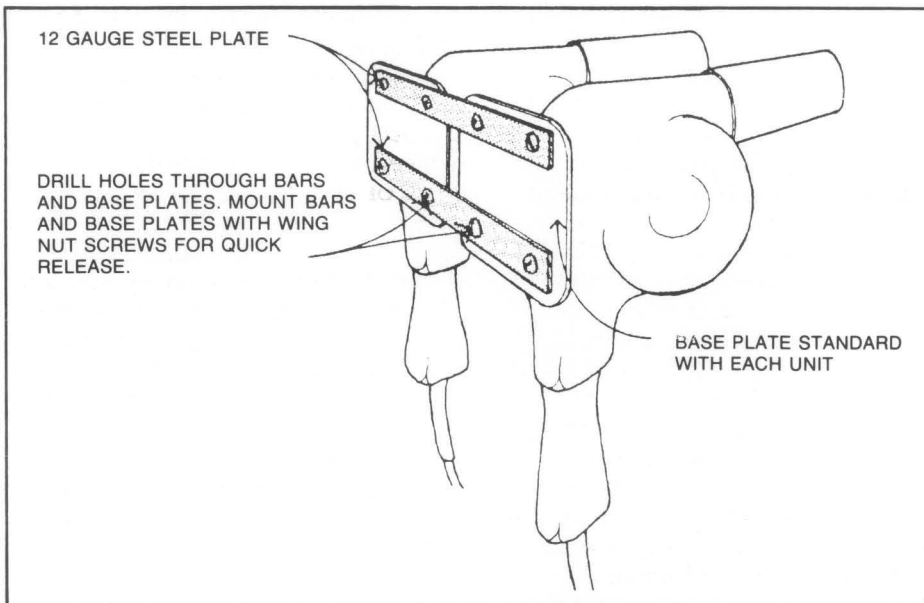
**Figure 4.** Method used to join two heat guns for simultaneous use. Drawing: Alan O'Bright

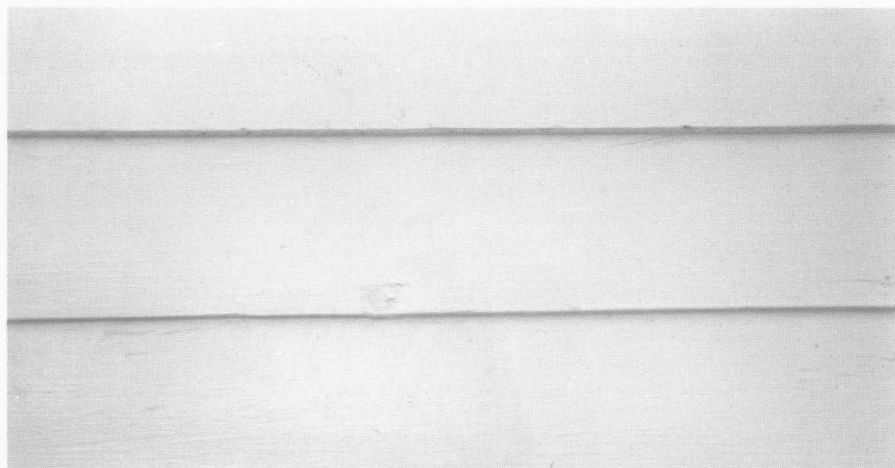
Areas on the Truman home where paint was removed with the heat guns and then lightly sanded provided an excellent painting surface (see figure 6). By using workers experienced with thermal removal of paint, very few scraper tool marks were left that were noticeable. The new paint bonded well to the wood

Figure 6. A typical section of the finish painted siding shows that little damage was done in removing the paint. Photo: Michael Lee
