# 31 PRESERVATION BRIEFS

## Mothballing Historic Buildings

Sharon C. Park, AIA

U.S. Department of the Interior  
National Park Service  
Cultural Resources  
Heritage Preservation Services

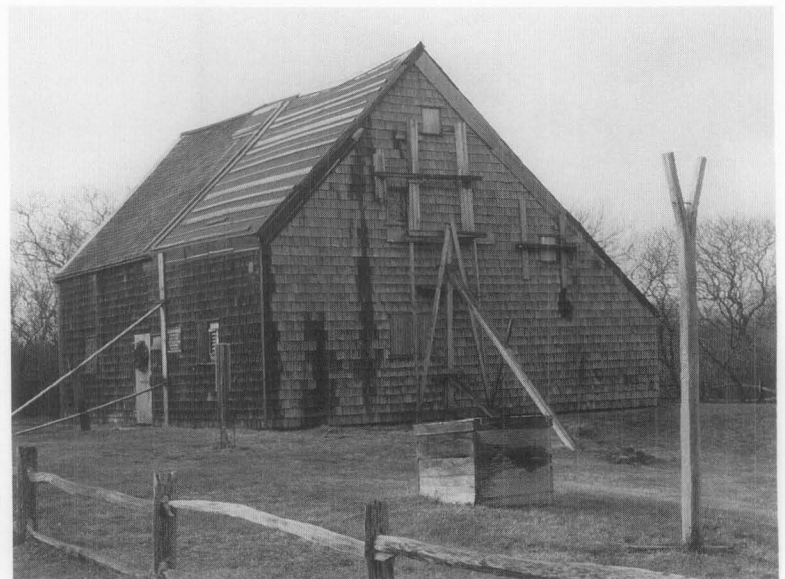
Figure 3. Buildings seriously damaged by storms or deterioration may need to be braced before architectural evaluations can be made. Jethro Coffin House. Photo: John Milner Architects.

to be structurally unsound until the condition of the structure can be fully assessed (see fig. 3). If pigeon or bat droppings, friable asbestos or other health hazards are present, precautions must be taken to wear the appropriate safety equipment when first inspecting the building. Consideration should be given to hiring a firm specializing in hazardous waste removal if these highly toxic elements are found in the building.

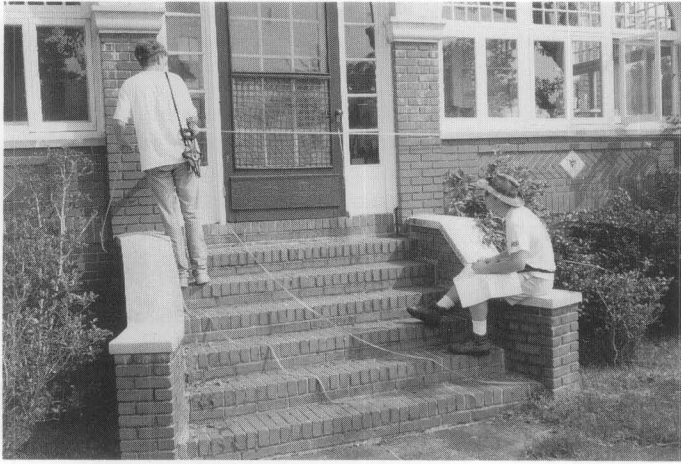
Figure 4. Documenting the building's history, preparing schematic plans, and assessing the condition of the building will provide necessary information on which to set priorities for stabilization and repair prior to securing the building. Photo: Frederick Lindstrom, HABS.

Old photographs can be helpful in identifying early or original features that might be hidden under modern materials. On a walk-through, the architect, historian, or preservation specialist should identify the architecturally significant elements of the building, both inside and out (see fig.4).

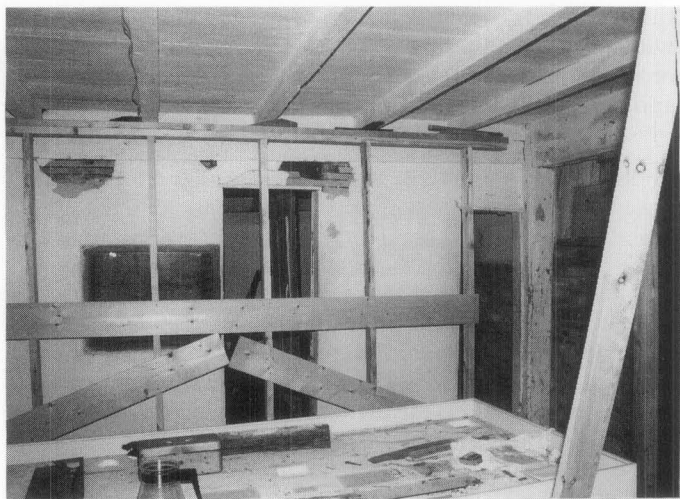
Figure 6. Interior bracing which will last the duration of the mothballing will protect weakened structural members. Jethro Coffin House. Photo: John Milner Architects.

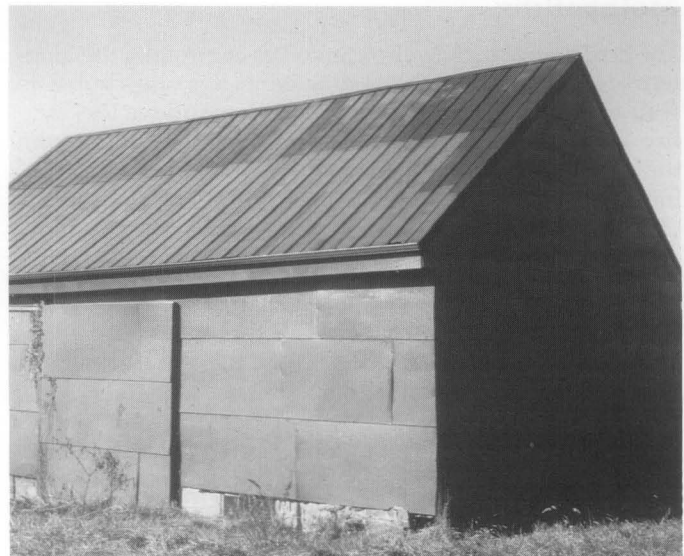
Figure 9. Severely deteriorated wooden siding on a farm building has been covered over with painted plywood panels as a temporary measure to eliminate moisture penetration to the interior. Foundation vents and loose floor boards allow air to circulate inside.

patterns or by installing panels over a frame of battens (see fig. 9). Generally, however, it is better to repair deteriorated features than to cover them over.

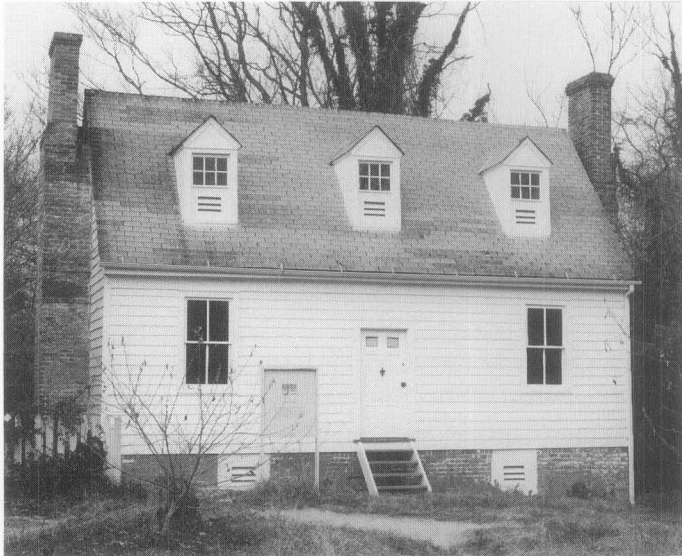
Figure 10. Regrading around the Booker Tenement at Colonial Williamsburg has protected the masonry foundation wall from excessive damp. This building has been successfully mothballed for over 10 years. Note the attic and basement vents, the temporary stairs, and the informative sign interpreting the history of this building.

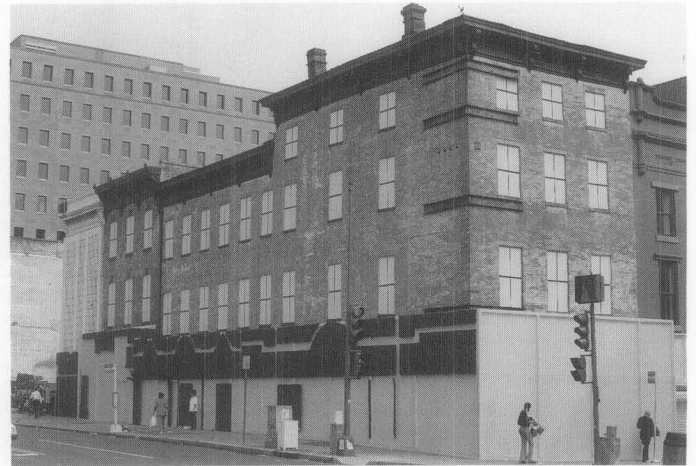
Figure 11. Urban buildings often need additional protection from unwanted entry and graffiti. This commercial building uses painted plywood panels to cover expansive glass storefronts and chain link fencing is applied on top of the panels. The upper windows on the street sides have been covered and painted to resemble 19th century sash. Photo: Thomas Jester, NPS.

Mothballed buildings are usually boarded up, particularly on the first floor and basement, to protect fragile glass windows from breaking and to reinforce entry points (see fig. 11). Infill materials for closing door and window openings include plywood, corrugated panels, metal grates, chain fencing, metal grills, and cinder or cement blocks (see fig. 12). The method of installation should not result in the destruction of the opening and all associated sash, doors, and frames should be protected or stored for future reuse.

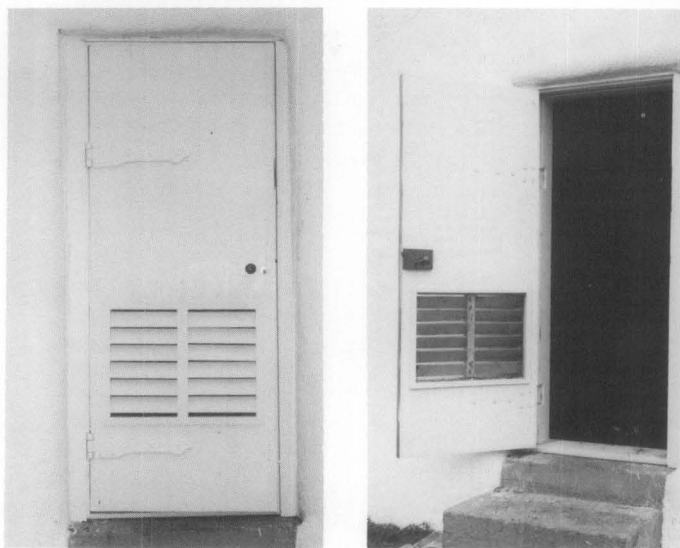
Figure 13. If historic doors would be damaged by adding extra locks, they should be removed and stored and new security doors added. At this lighthouse, the historic door has been replaced with a new door (seen both inside and outside) with an inset vent and new deadbolt locks. The heavy historic hinges have not been damaged. Photo: Williamsport Preservation Training Center, NPS.

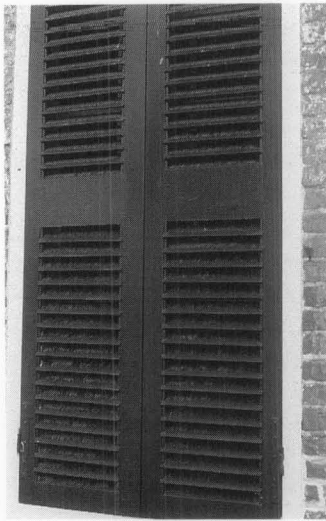
Figure 16. Historic louvered shutters make excellent security closures with passive ventilation.

If the building has shutters, simply close the shutters and secure them from the interior (see fig. 16). If the building had shutters historically, but they are missing, it may be appropriate to install new shutters, even in a modern material, and secure them in the closed position. Louvered shutters will help with interior ventilation if the sash are propped open behind the shutters.

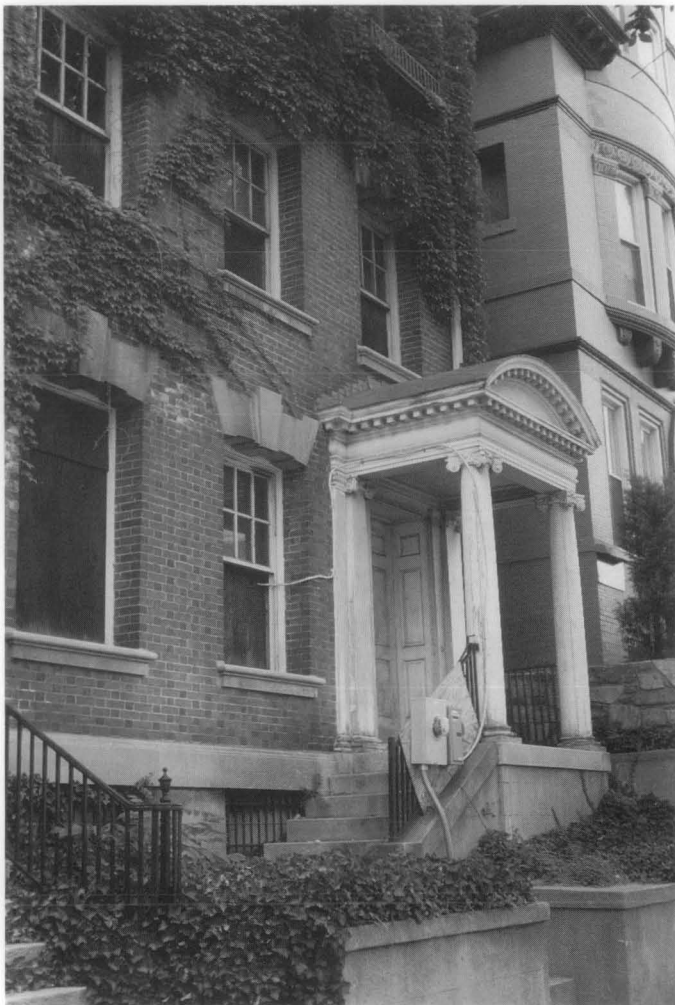
Figure 22. All systems except temporary electric have been shut off at this residence which has been mothballed over 20 years. An electric meter and 100 amp panel box have been set on a plywood panel at the front of the building. It is used for interior lighting and various alarm systems. The building, however, is showing signs of moisture problems with efflorescent stains on the masonry indicating the need for gutter maintenance and additional ventilation for the interior. The vegetation on the walls, although picturesque, traps moisture and is damaging to the masonry. Photo: H. Ward Jandl, NPS.

hazard, it is advisable to retain those which will help protect the property. Since the electrical needs will be limited in a vacant building, it is best to install a new temporary electric line and panel (100 amp) so that all the wiring is new and exposed. This will be much safer for the building, and allows easy access for reading the meter (see fig. 22).

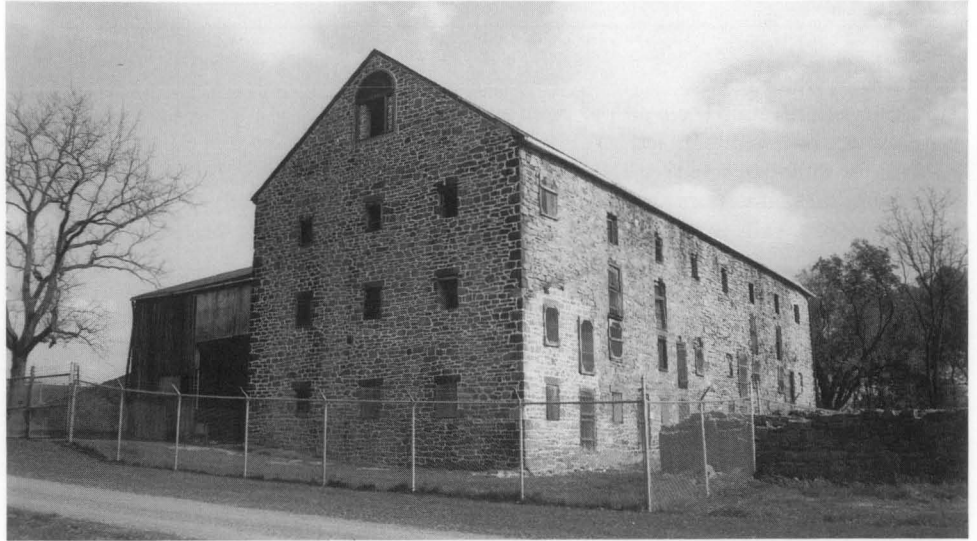
Figure 24. Once mothballed, a property must still be monitored and maintained. The openings in this historic barn has been modified with a combination of wood louvers and metal mesh panels which require little maintenance. The grounds are regularly mowed, even inside the chain link security fence. Photo: Williamsport Preservation Training Center, NPS.

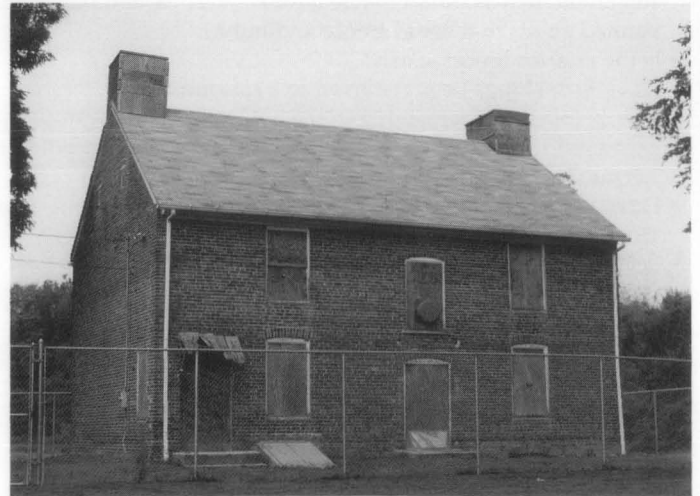
a. A view showing the exterior of the house in its mothballed condition.

Figure 25. Above is a summary of the tasks that were necessary in order to protect this significant property while restoration funds are raised. Photographs: Michael Mills; Ford Farewell Mills Gatsch Architects.

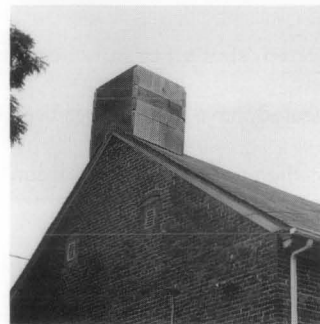
b. Plywood panels stabilize the chimneys. Note the gable vents.

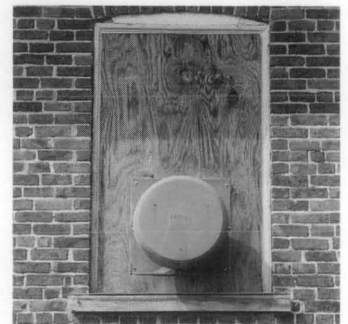
c. The exhaust fan has tamper-proof housing.
