19 PRESERVATION BRIEFS

The Repair and Replacement of Historic Wooden Shingle Roofs

Sharon C. Park, AIA

U.S. Department of the Interior, National Park Service
Preservation Assistance Division, Technical Preservation Services

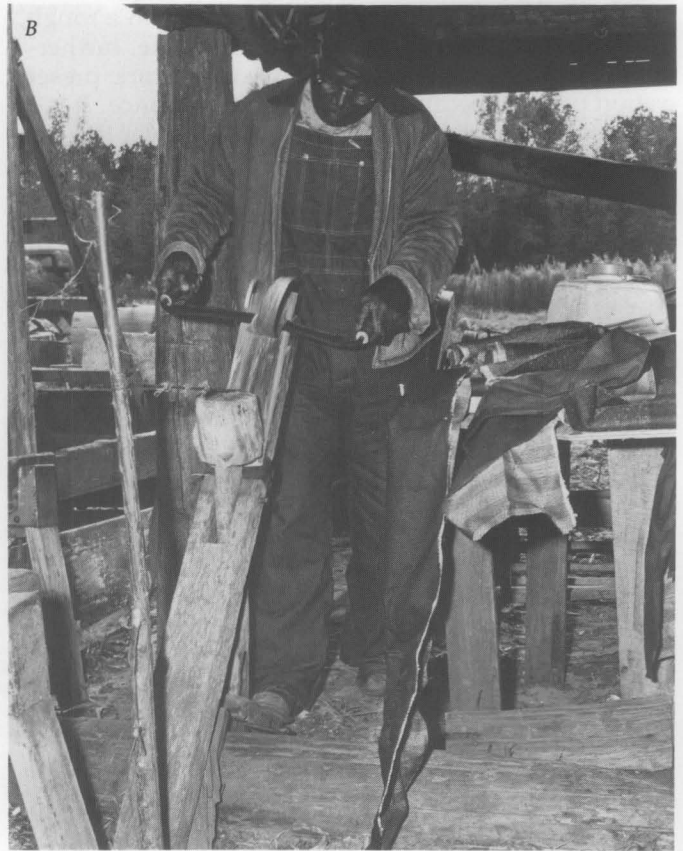
5. Custom Handsplit shingles are still made the traditional way with a mallet and froe or ax. For these cypress shingles, a "bolt" section of log (photo A) the length of the shingle has been sawn and is ready to be split into wedge-shaped segments. Handsplit shingles are fabricated with the ax or froe cutting the wood along the grain and separating, or riving, the shingle away from the remaining wedge. The rough surfaces are dressed on a shavinghorse using a draw-knife as shown above (photo B). Note the long wooden shingles covering the work shed in photo A. Photos: Al Honeycutt, North Carolina Division of Archives and History.

to dress or plane the shingles on a shavinghorse with a draw-knife or draw-shave (see illus. 5B) to make them fit evenly on the roof. This reworking was necessary to provide a tight-fitting roof over typically open shingle lath or sheathing boards. Dressing, or smoothing of shingles, was almost universal, no matter what wood was used or in what part of the country the building was located, except in those cases where a temporary or very utilitarian roof was needed.

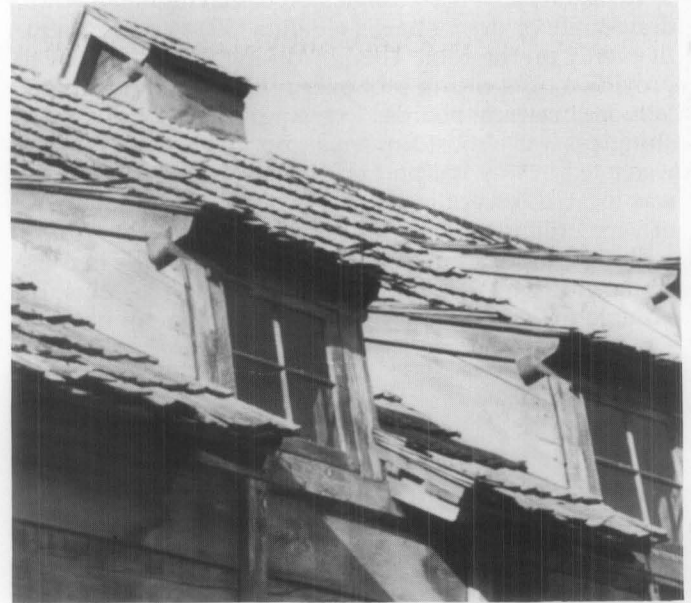
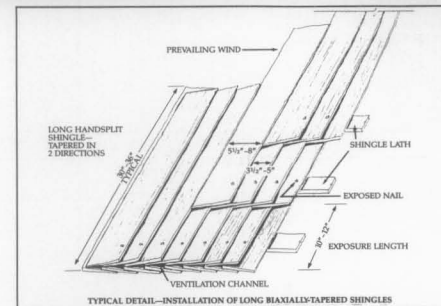
8. The long biaxially tapered handsplit shingles on the Ephrata Cloisters in Pennsylvania were overlapped both vertically and horizontally. The insert sketch shows channels under the shingles that provided ventilation and drainage of any trapped moisture. The aged appearance of these handsplit and dressed shingles belies their original smoothness. Replacement shingles should match the original, not the aged appearance. Photo: National Park Service; Sketch: Reed Engle.

Not all shingles were laid in evenly spaced, overlapping, horizontal rows. In various regions of the country, there were distinct installation patterns; for example, the biaxially-tapered long shingles occasionally found in areas settled by the Germans (see illus. 8). These long shingles were overlapped on the side as well as on top. This formed a ventilation channel under the shingles that aided drying. Because ventilation of the shingles can prolong their life, roofers paid attention to these details (see illus. 9).

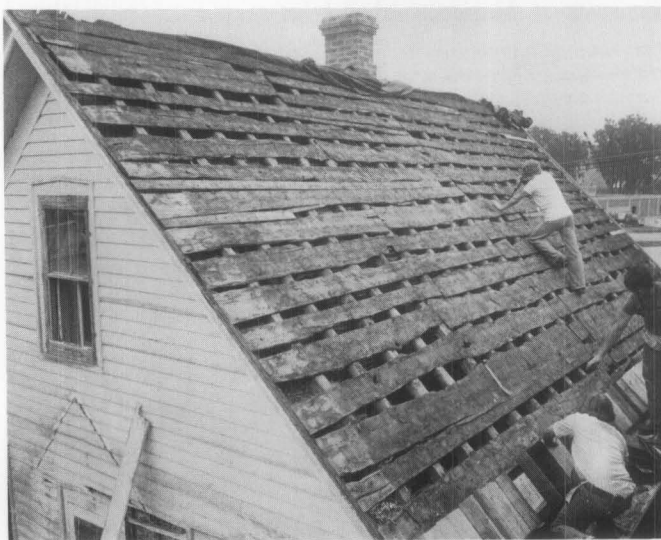
7. The reshingling of the circa 1856 Stovewood House in Decorah, Iowa, revealed the original open sheathing boards and pole rafters. Sawn cedar shingles were used as a replacement for the historic cedar shingles seen still in place at the ridge. A new starter course is being laid at the eaves. Photo: Norwegian-American Museum, Decorah, Iowa.

In order to have a weathertight roof, it was important to have adequate coverage, proper spacing of shingles, and straight grain shingles. Many roofs were laid on open shingle lath or open sheathing boards (see illus. 7). Roofers typically laid three layers of shingles with approximately 1/3 of each shingle exposed to the weather. Spaces between shingles (1/8"–1/2" depending on wood type) allowed the shingles to expand when wet. It was important to stagger each overlapping shingle by a minimum of 1-1/2" to avoid a direct path for moisture to penetrate a joint. Doubling or tripling the starter course at the eave gave added protection to this exposed surface. In order for the roof to lay as flat as possible, the thickness, taper and surface of the shingles was relatively uniform; any unevenness on handsplit shingles had already been smoothed away with a drawknife. To keep shingles from curling or cupping, the shingle width was generally limited to less than 10".

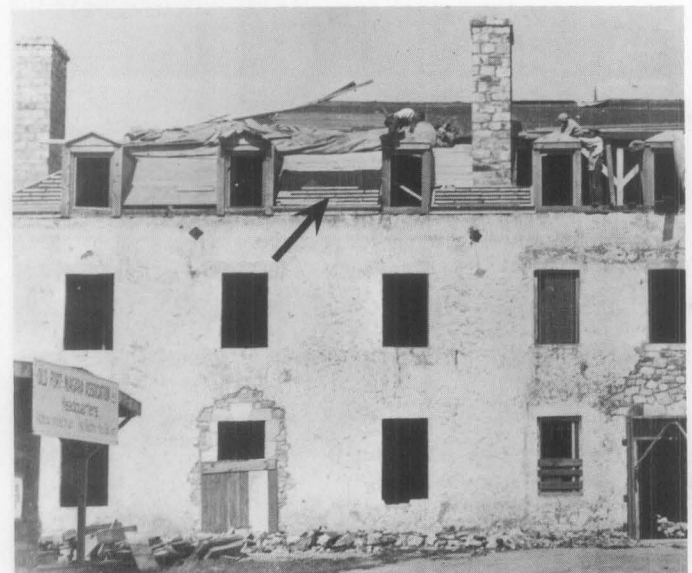
9. This 1927 view of the reshingling of the French Castle at Old Fort Niagara, N.Y., shows the wooden sleepers being laid (see arrow) over solid sheathing in order to raise the shingles up slightly to allow under-shingle ventilation. Note that the horizontal strips are not continuous to allow airflow and trapped moisture to drain away. This cedar roof has lasted for over 60 years in a harsh moist environment. Photo: Old Fort Niagara, Assoc. Inc.

Beware of heavily insulated attic rafters. Historically, the longest lasting shingle roofs were generally the ones with the best roof ventilation. Roofs with shingling set directly on solid sheathing and where there is insulation packed tightly between the wooden rafters without adequate ventilation run the risk of condensation-related moisture damage to wooden roofing components. This is particularly true for air-conditioned structures. For that reason, if insulation must be used, it is best to provide ventilation channels between the rafters and the roof decking, to avoid heavy felt building papers, to consider the use of vapor barriers, and perhaps to raise the shingles slightly by using "sleepers" over the roof deck. This practice was popular in the 1920s in what the industry called a "Hollywood" installation, and examples of roofs lasting 60 years are partly due to this under-shingle ventilation (refer to illus. 9).

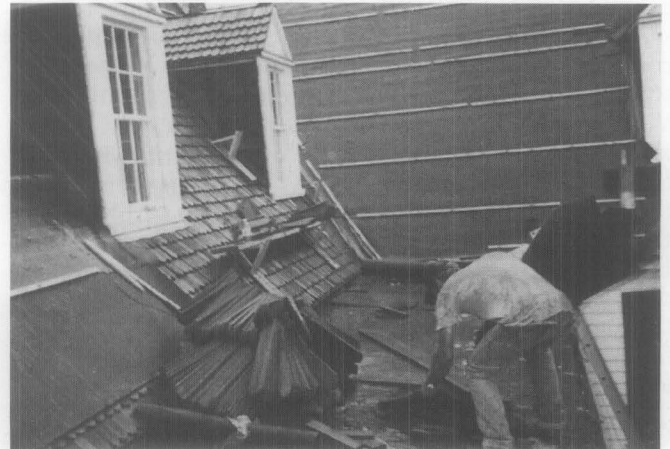
C. The replacement shingles (see specifications above), matched the historic shingles and were of such high quality that little hand dressing was needed at the site. The building paper, a temporary protection, was removed as the shingles were installed on the sheathing boards.

Type of wood to be used: Western Red Cedar.
Grade of wood and manufacturing process: Number One, Tapersplit Shakes, 100% clear, 100% edgegrain, 100% heartwood, no excessive grain sweeps, curvatures not to exceed 1/2" from level plain in length of shake; off grade (7% tolerance) material must *not* be used.
Size of the shingle: 18" long, 5/8" butt tapered to 1/4" head, 3"-4" wide, sawn curved butts, 5-1/2" exposure
Surface finish and any applied coatings: relatively smooth natural grain, no more than 1/8" variation in surface texture, butt thickness to be uniform throughout bundles. Site dipped with fire-rated chemicals tinted with red iron oxide for opaque color.
Type of nails and flashing: double hot dipped galvanized nails sized to penetrate sheathing totally; metal flashing to be 20 oz. lead-coated copper, or terne-coated stainless steel; additional flashing reinforcement to be aluminum foil type with fiber backing to use at hips, ridges, eaves, and valleys.

Type of sheathing: uninsulated attic, any deteriorated 3/4" sheathing boards, spaced 1/2"-3/4", to be replaced in kind.

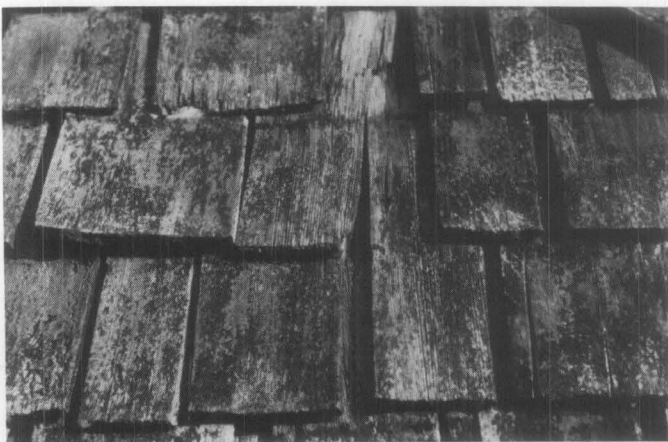
16. Routine maintenance is necessary to extend the life of the roof. On this roof, the shingles have not seriously eroded, but the presence of lichens and moss is becoming evident and there are a few cracked and missing shingles. The moss spores should be removed, missing shingles replaced, and small pieces of metal flashing slipped under cracked shingles to keep moisture from penetrating. Photo: Williamsport Preservation Training Center.

Periodic maintenance inspections of the roof may reveal loose or damaged shingles that can be selectively replaced before serious moisture damage occurs (see illus. 16). Keeping the wooden shingles in good condition and repairing the roof, flashing and guttering, as needed, can add years of life to the roof.
