THE SECRETARY
OF THE INTERIOR'S
**STANDARDS FOR
THE TREATMENT
OF HISTORIC
PROPERTIES**

WITH
**GUIDELINES FOR
PRESERVING,
REHABILITATING,
RESTORING &
RECONSTRUCTING
HISTORIC
BUILDINGS**

U.S. Department of the Interior
National Park Service
Technical Preservation Services

2017

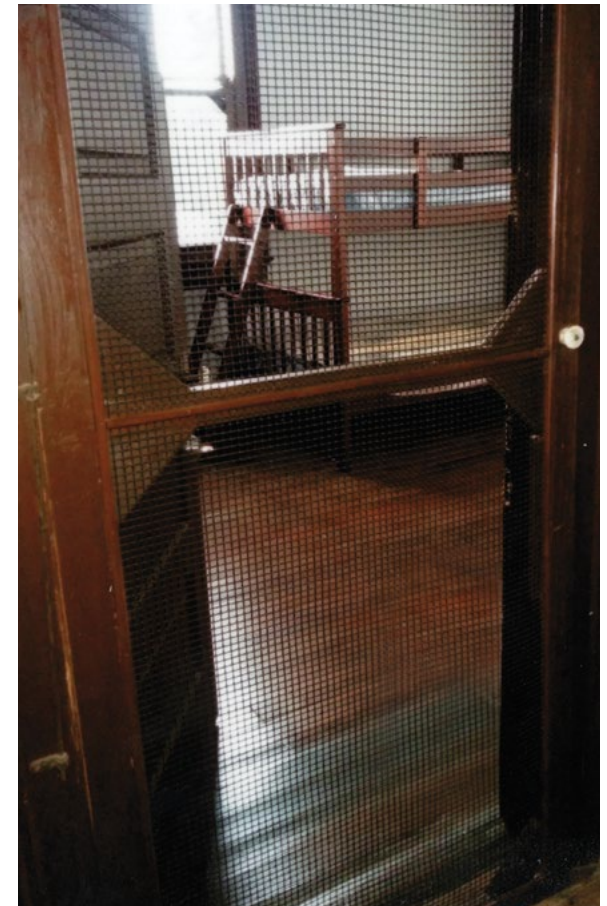
[31] An interior screen door at the entrance to individual apartments is a historic feature traditionally used to help circulate air throughout the building.
