16 PRESERVATION BRIEFS

The Use of Substitute Materials on Historic Building Exteriors

National Park Service
U.S. Department of the Interior
Technical Preservation Services

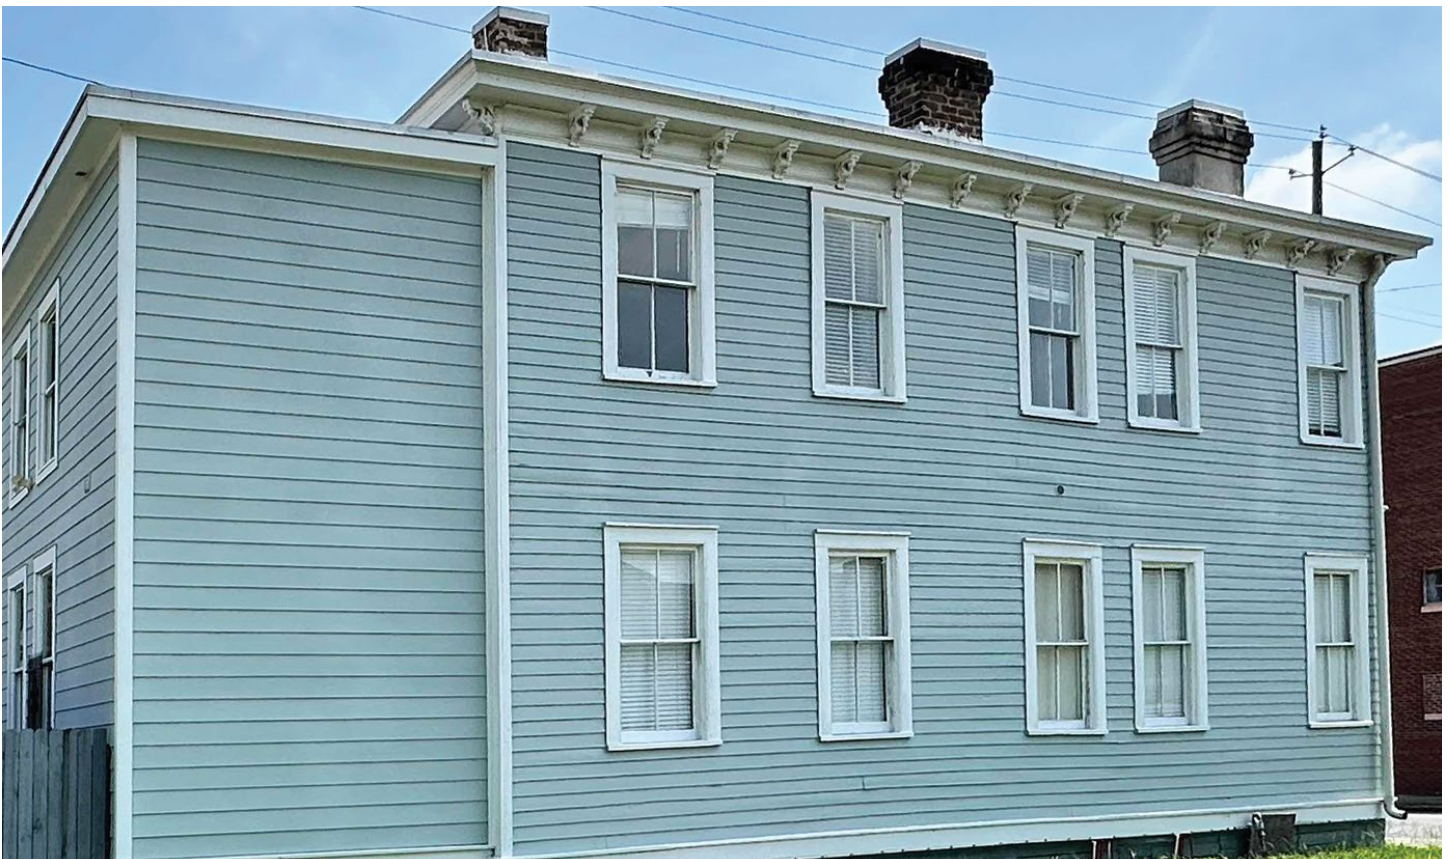
Figure 7. A new addition replaced non-historic construction on the rear elevation of this building. Fiber cement gives the addition a compatible appearance without replicating the exposure for thickness of the historic siding. Photo: Ward Architecture + Preservation.

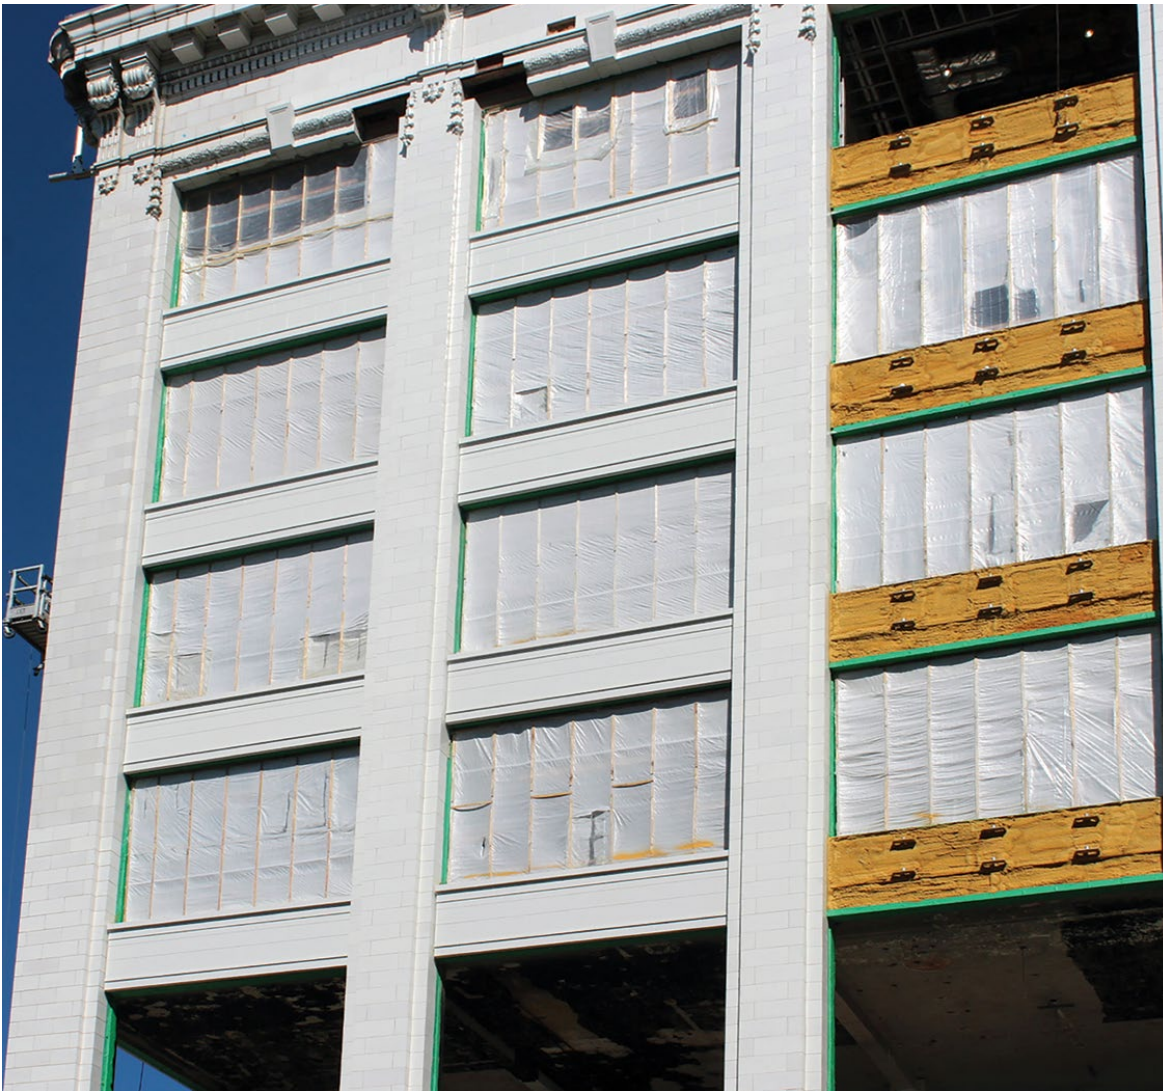
Figure 18. Missing historic terra cotta spandrel panels on all floor levels were recreated utilizing glass fiber reinforced concrete (GFRC) replacements. New spandrels were fabricated as individual components and attached with metal clips between historic terra cotta piers. Photo: Kris Frail, Dewberry.

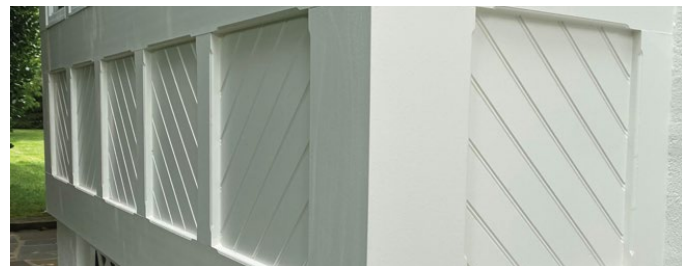
Figure 24. Cellular PVC when painted can be used to replace deteriorated wood features. This beadboard set in a wood frame was not historically designed to shed water effectively and had deteriorated. Cellular PVC was able to match the appearance of the wood details, while its properties were well matched to the shady location, painted finish, and limited size and configuration within the overall assembly; thus, it should provide a long-lasting solution for this application. Photo: Jennifer Balson Alvarez, NPS.
