# Tech Notes

## WINDOWS

NUMBER 9

### Interior Storm Windows: Magnetic Seal

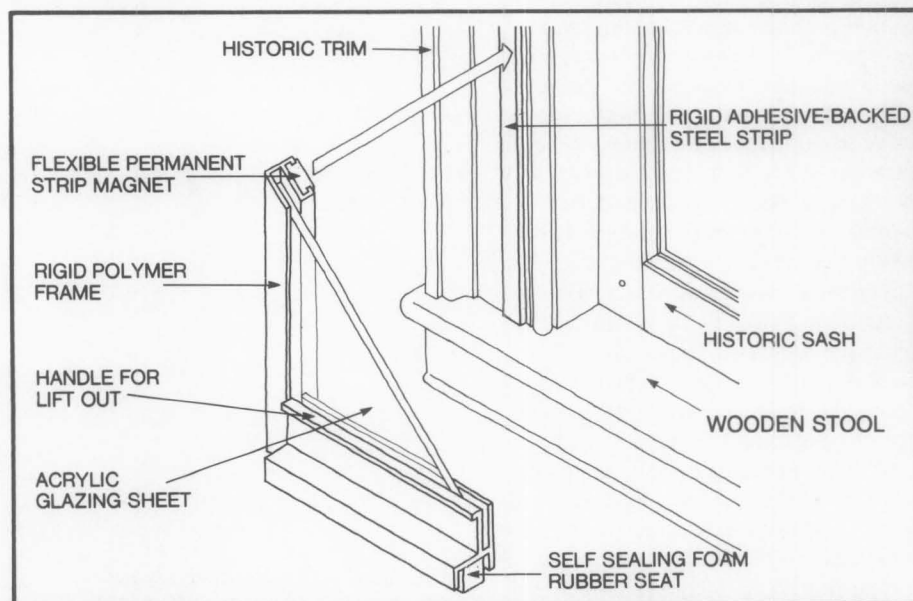
Figure 2. The thin-framed storm unit is shown attached by a magnetic seal to the existing trim. The protective film on the acrylic will later be removed. Photo: Tom H. Taylor.

Most of the historic windows at Colonial Williamsburg had been trimmed with a stool so that a magnetic seal was obtained only on three sides of the polymer frame (see figure 2). A small metal angle frame or wood stop could have been added to the stool to permit a magnetic seal on the fourth side but such alterations were avoided.

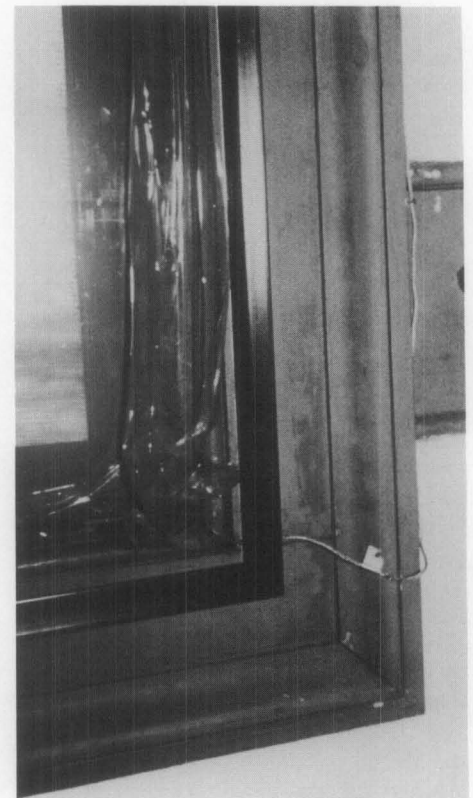
Figure 1. The interior storm window system chosen consisted of a clear acrylic glazing sheet set into a polymer frame that adhered to the existing window trim through use of a magnetic seal. Drawing: Christina Henry.

A slightly different polymer frame configuration was used for the bottom of the storm window in cases where a window stool existed. The sill framing was attached to the acrylic sheet like the typical polymer frame, with the exception that the bottom was extruded with a 1/4" U-channel that had a latex gasket glued in place to form a tight seal (see figure 1).

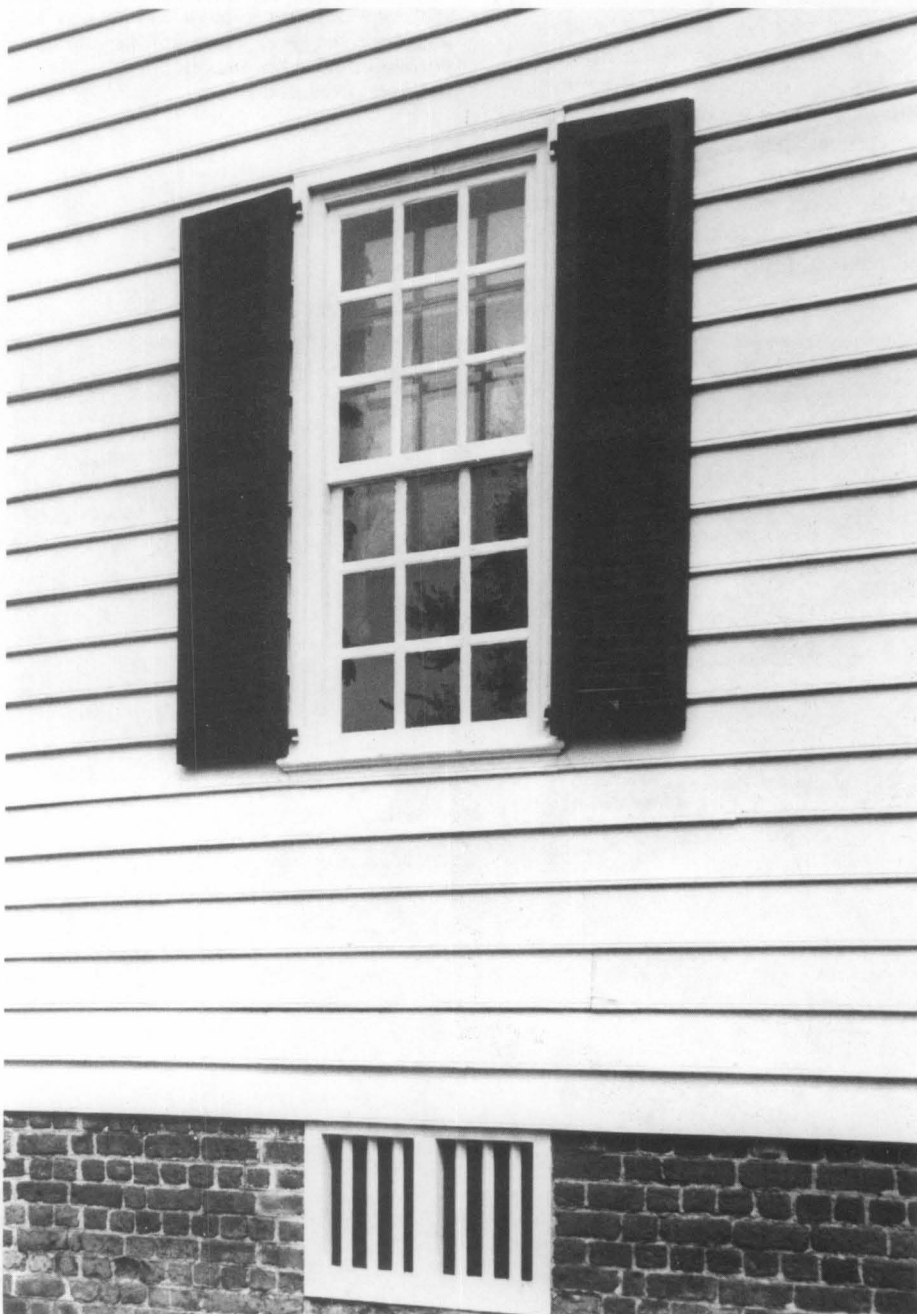
Figure 8. The unobtrusive interior storm window required no physical damage or exterior visual alteration to the original window. Photo: Tom H. Taylor.

The unobtrusive nature of these storm windows is an advantageous feature, along with the fact that no physical damage or alteration to the original window is required (*see figure 8*).
